## 2.0 ANALYSIS

## **2.5 Analysis of the chronological main events**

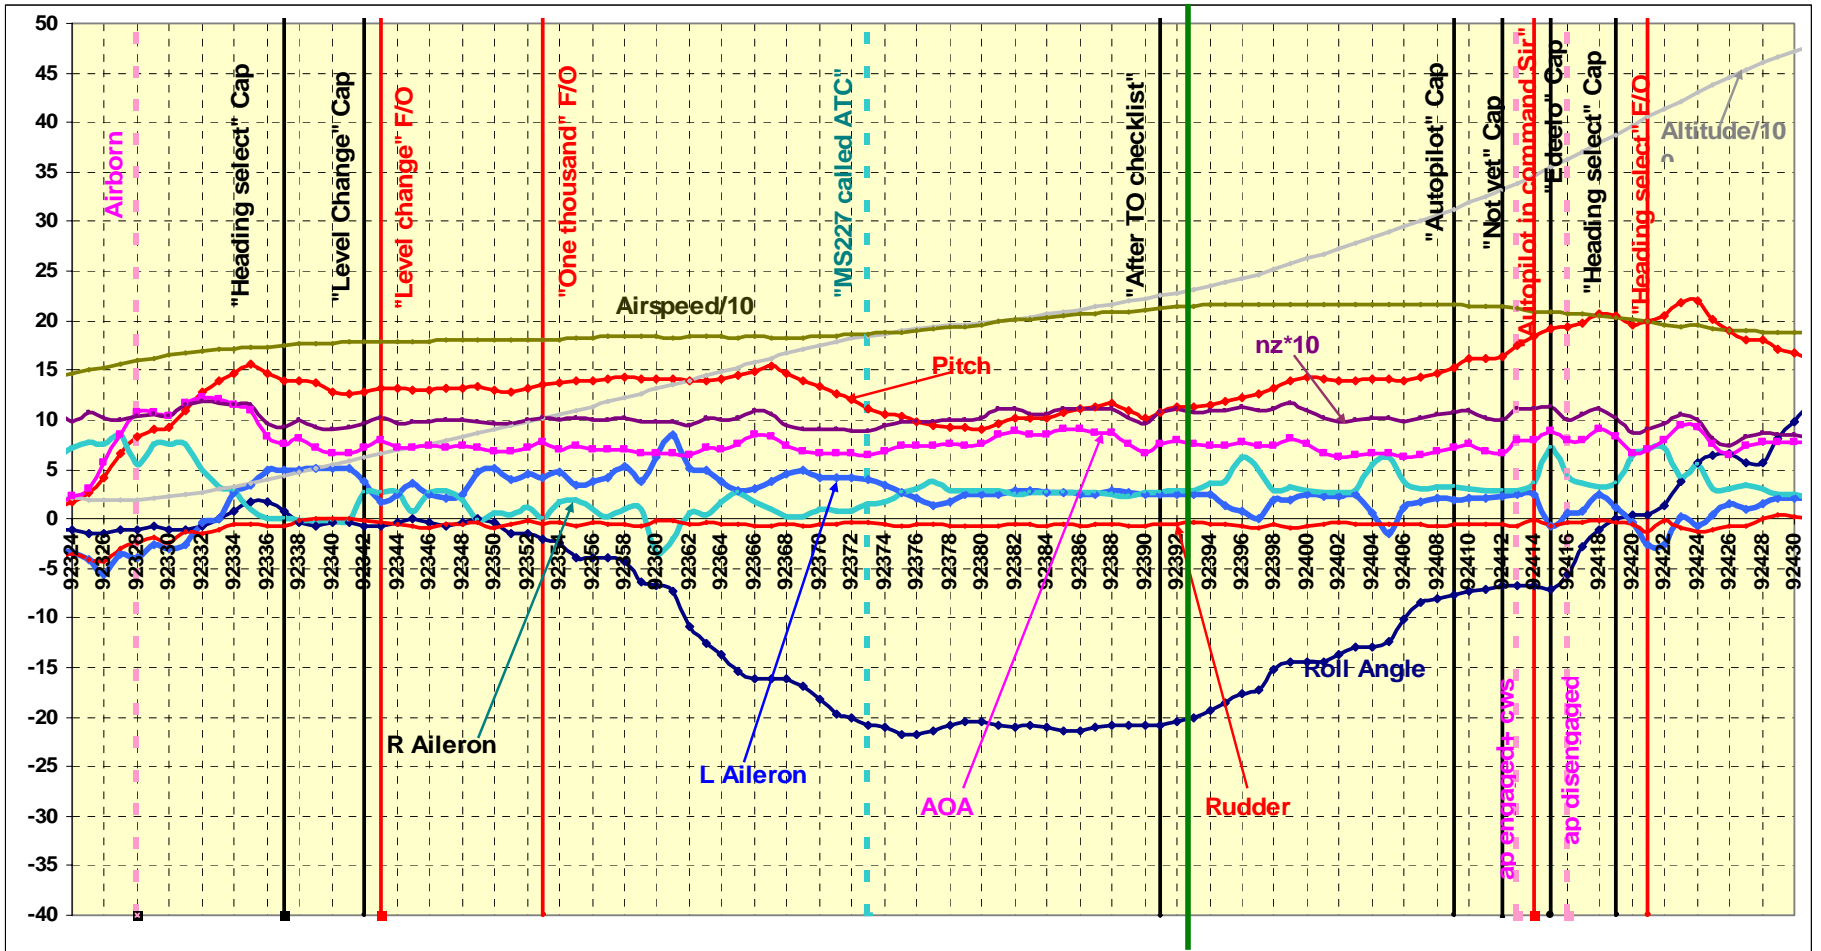
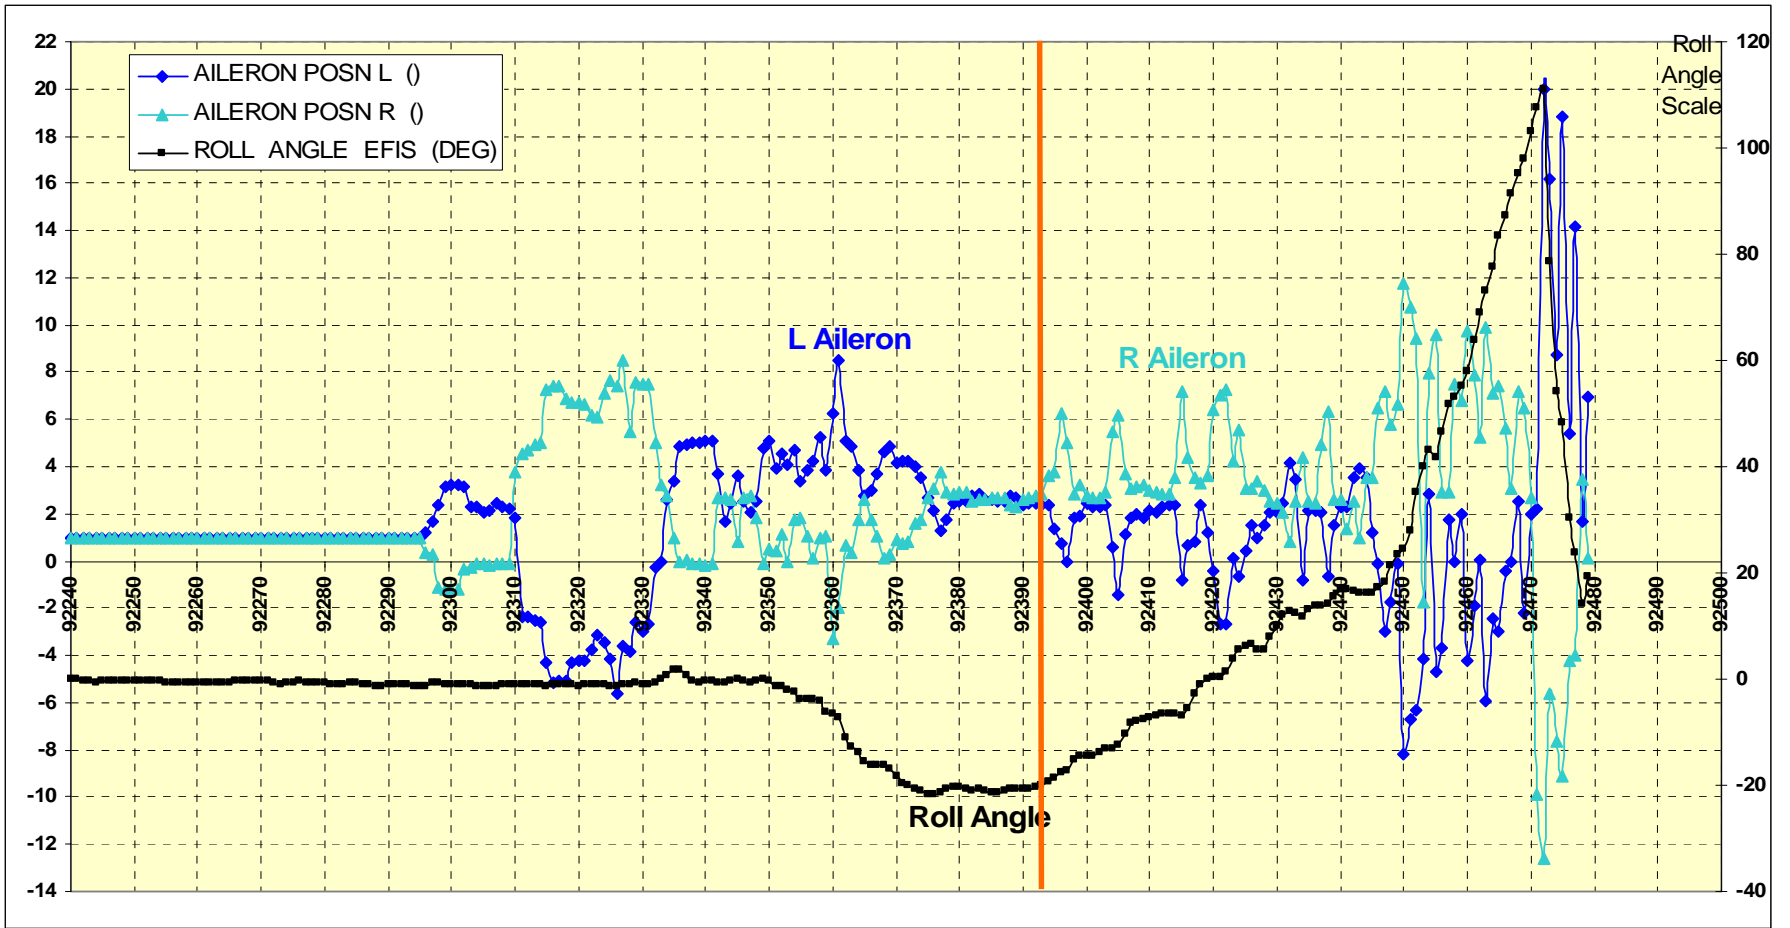
Figure 2.5.9.1a Aileron Move in direction of right roll

Based on the FDR, the ailerons started moving in the direction requesting for airplane right roll almost after 92392

Based on the FDR data, and starting from about the time frame 92393 the right aileron showed upward movement (TEU), the left aileron showed downward movement. This movement direction continued up to the 92471 timeframe after which airplane recovery attempt was made.

The investigation could not determine a higher possibility to any of the above findings (lateral system fault, pilot input) based on the given data.

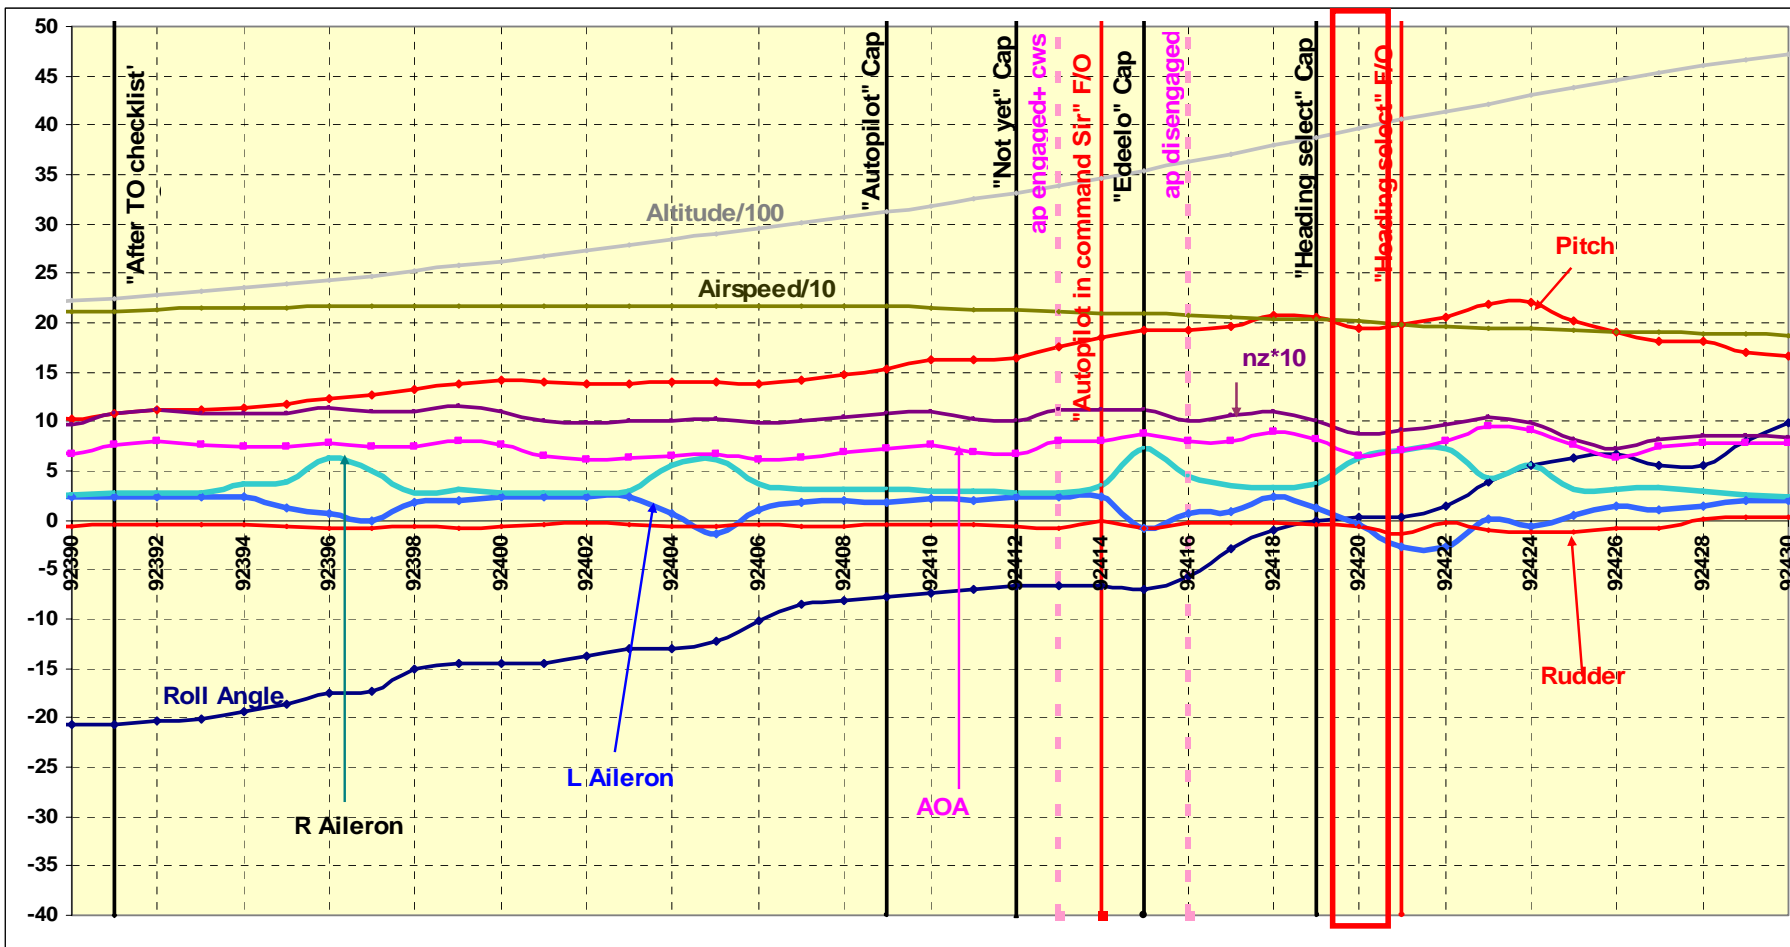
Figure 2.5.11.1 Airplane begins roll to right

Based on the FDR data, the airplane stopped the left turn and started a right turn at about 92420

After completing the process of elimination of the unlikely conditions shown above, the investigation could not determine a higher possibility to any of the above findings based on the given data.

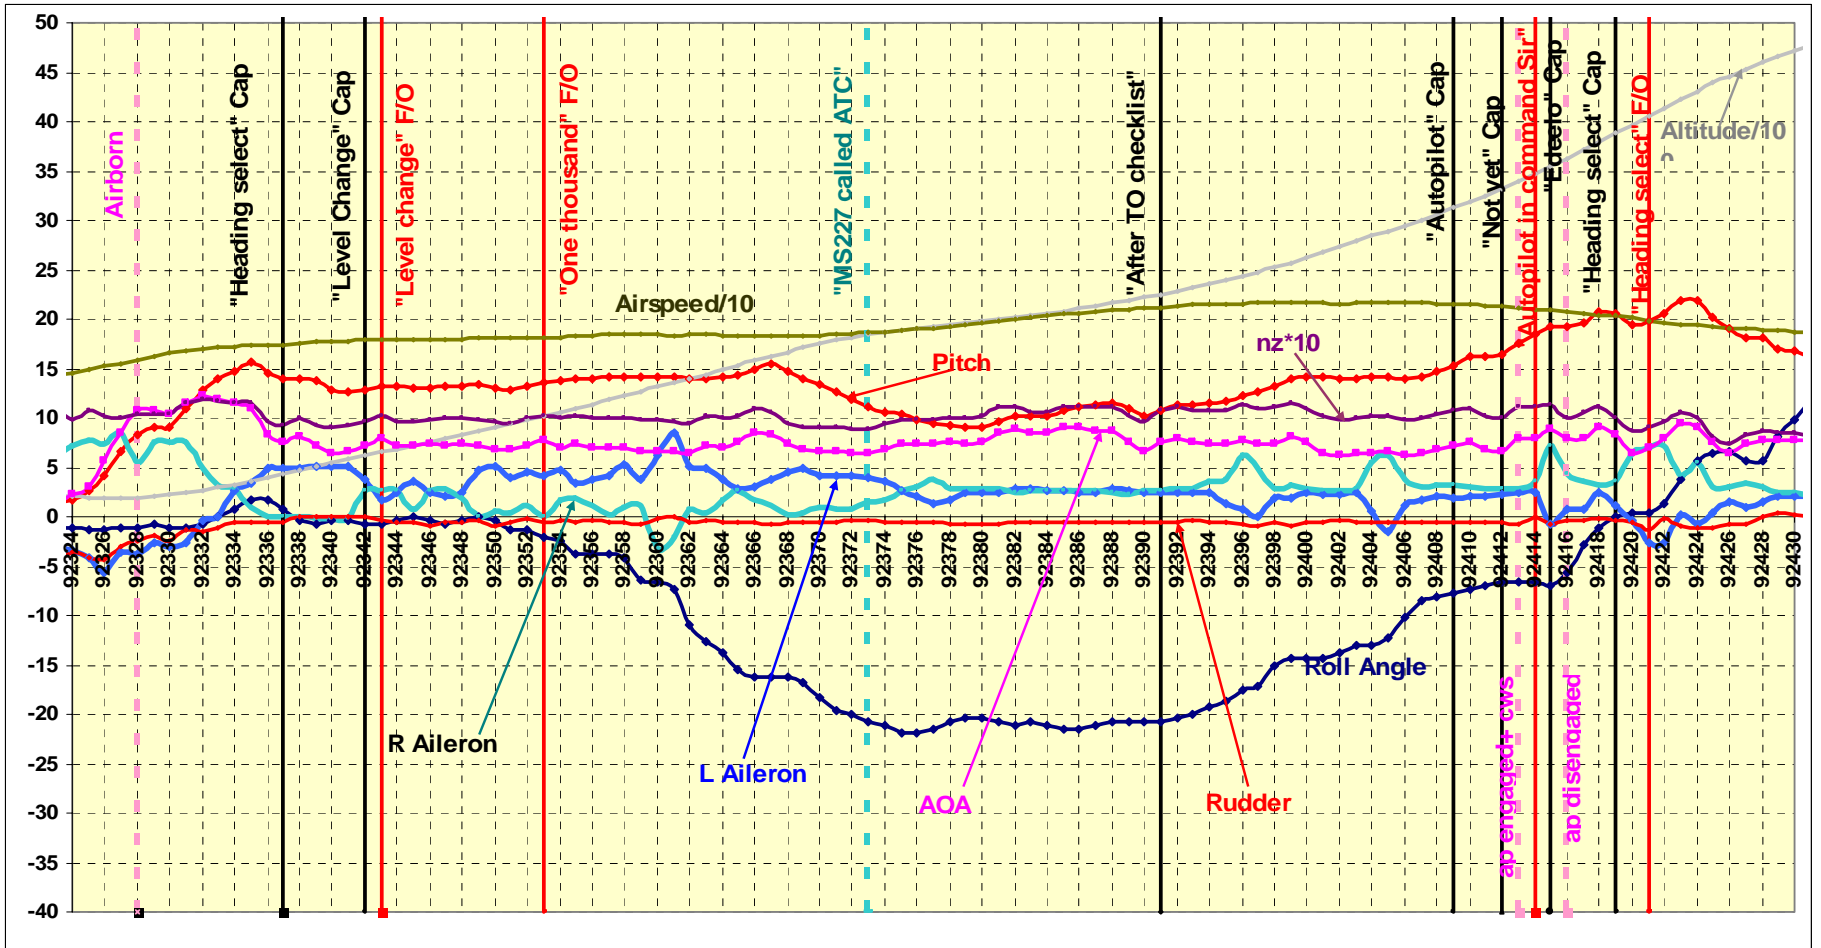
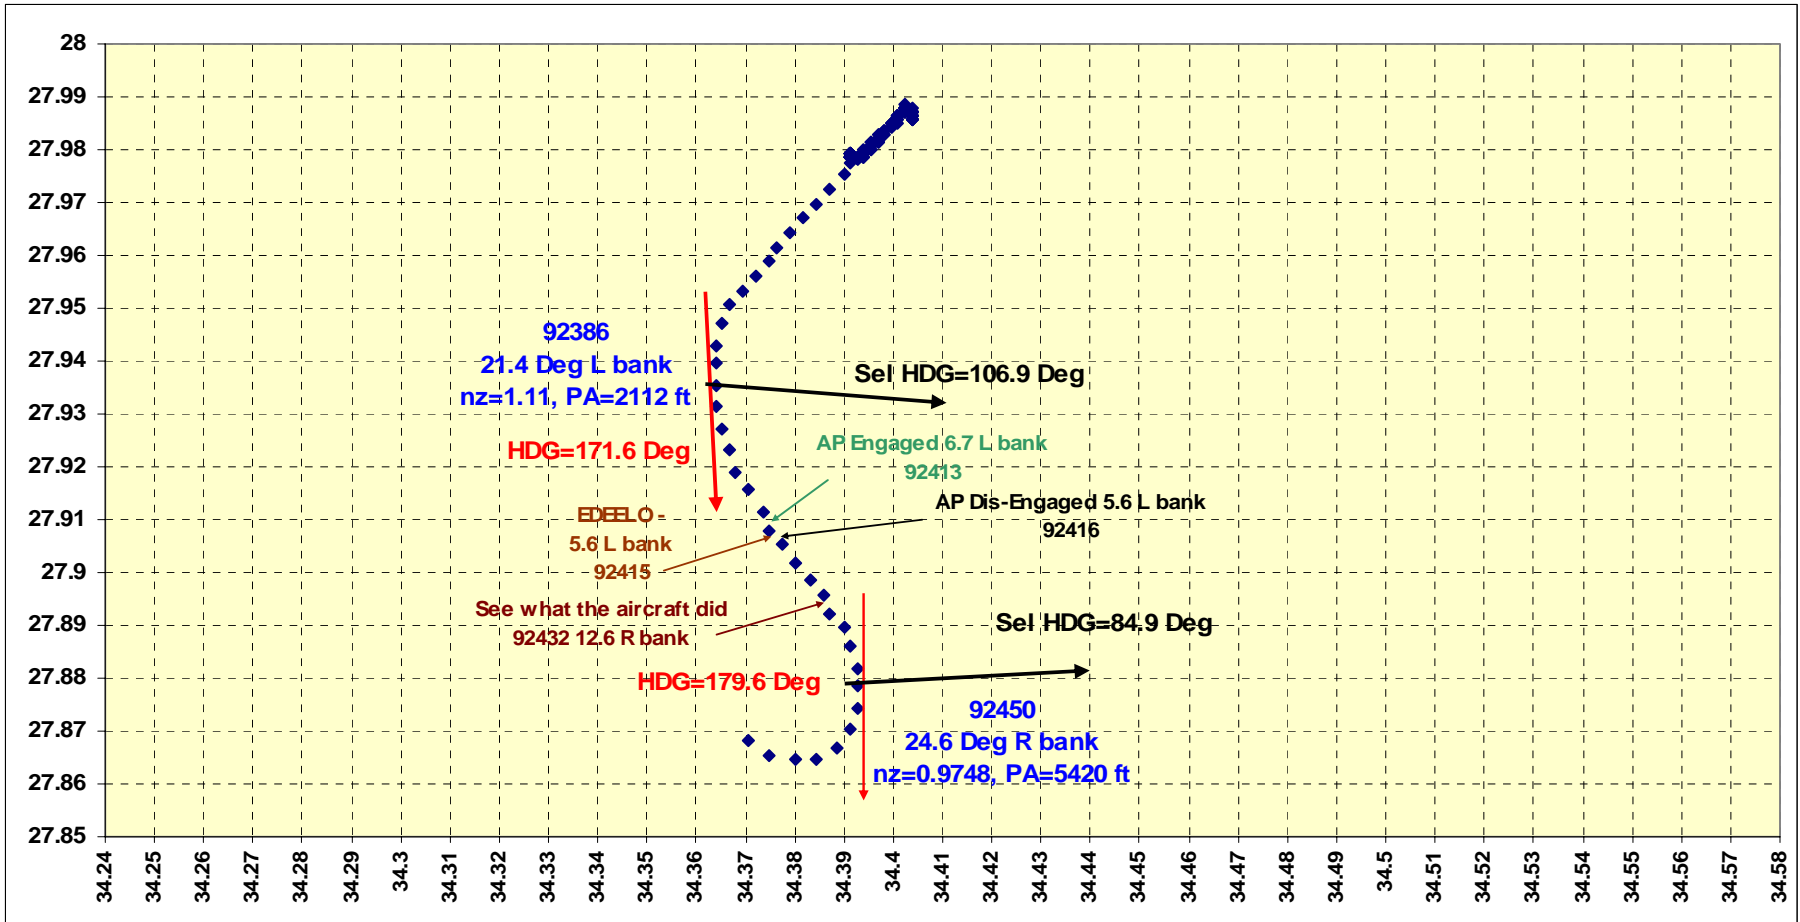
Figure 2.5.12.1 Heading Select engaged

- At time 02:44:05 (92419), the Captain requested "heading select".
- At time 02:44:07 (92421), the F/O states "heading select" and the FDR records heading select mode engaging.

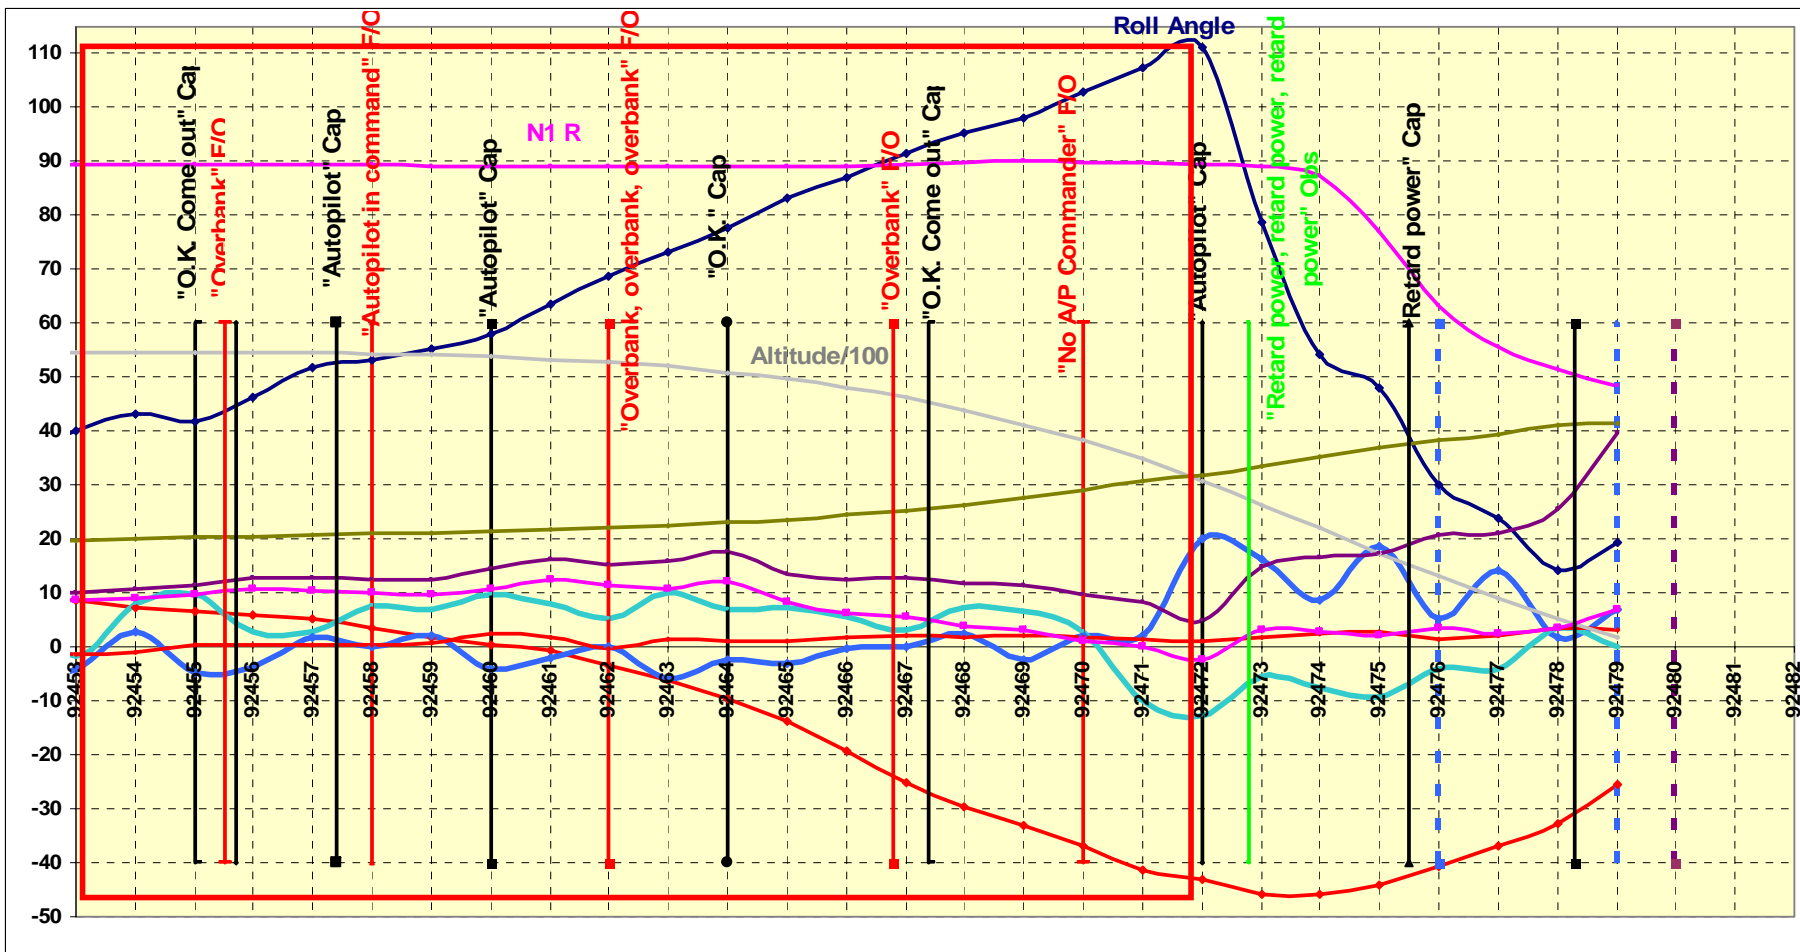
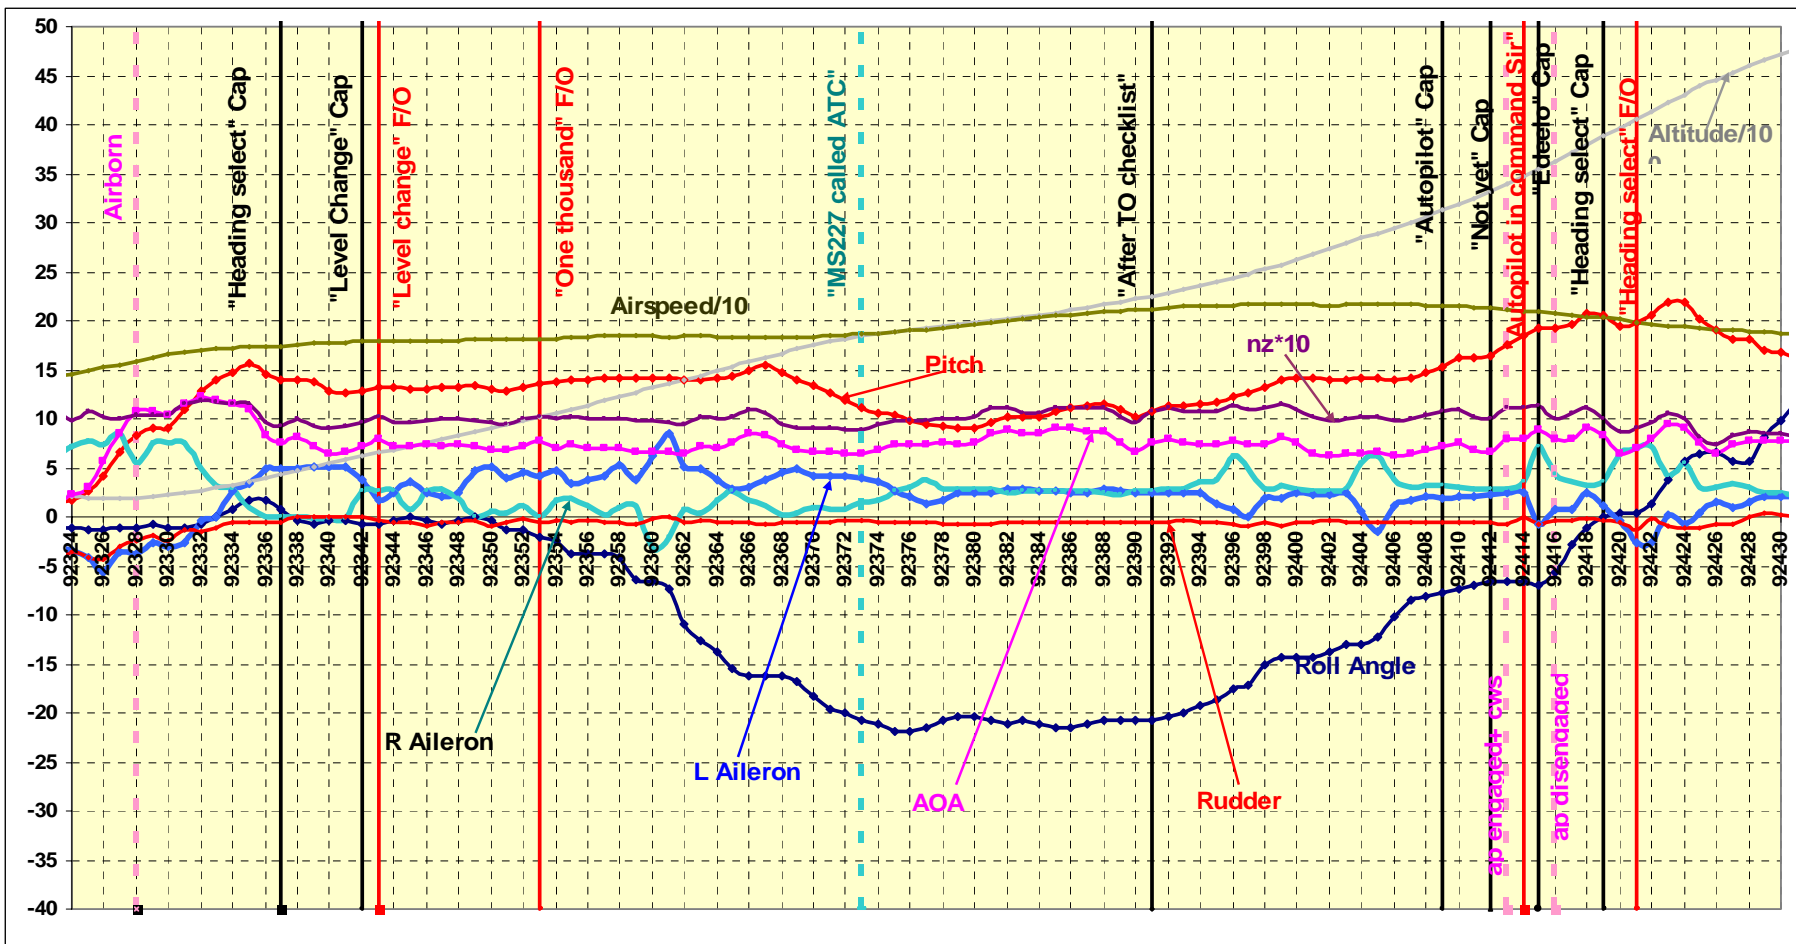
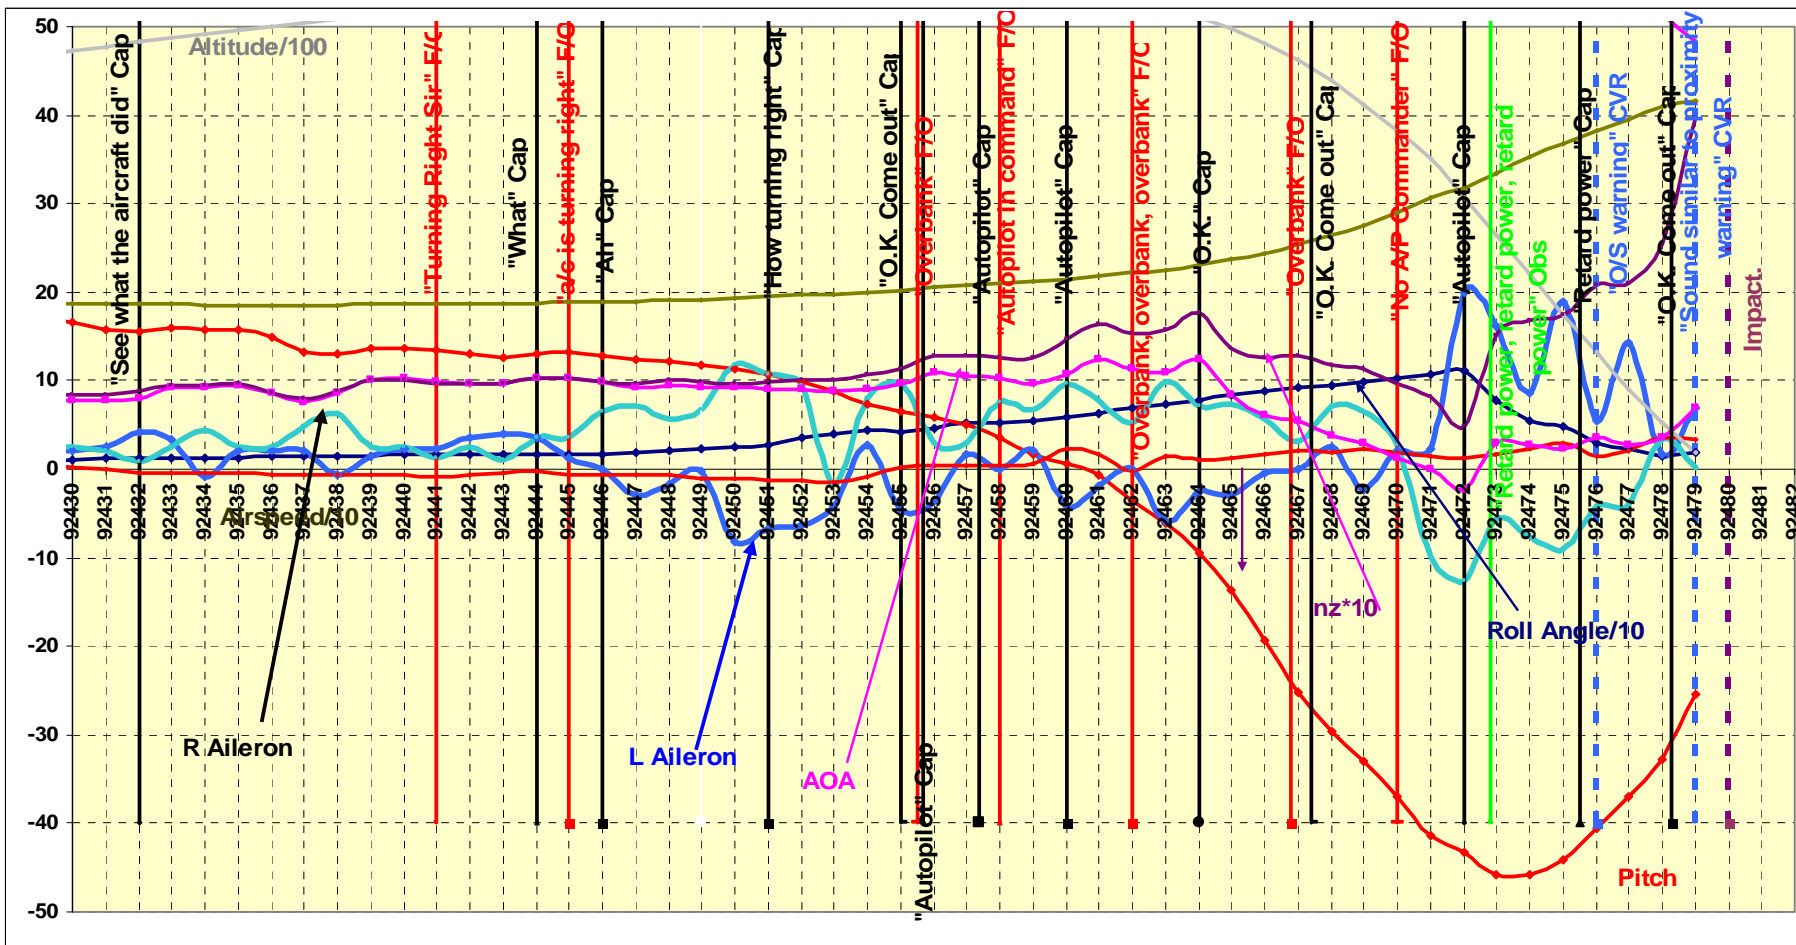
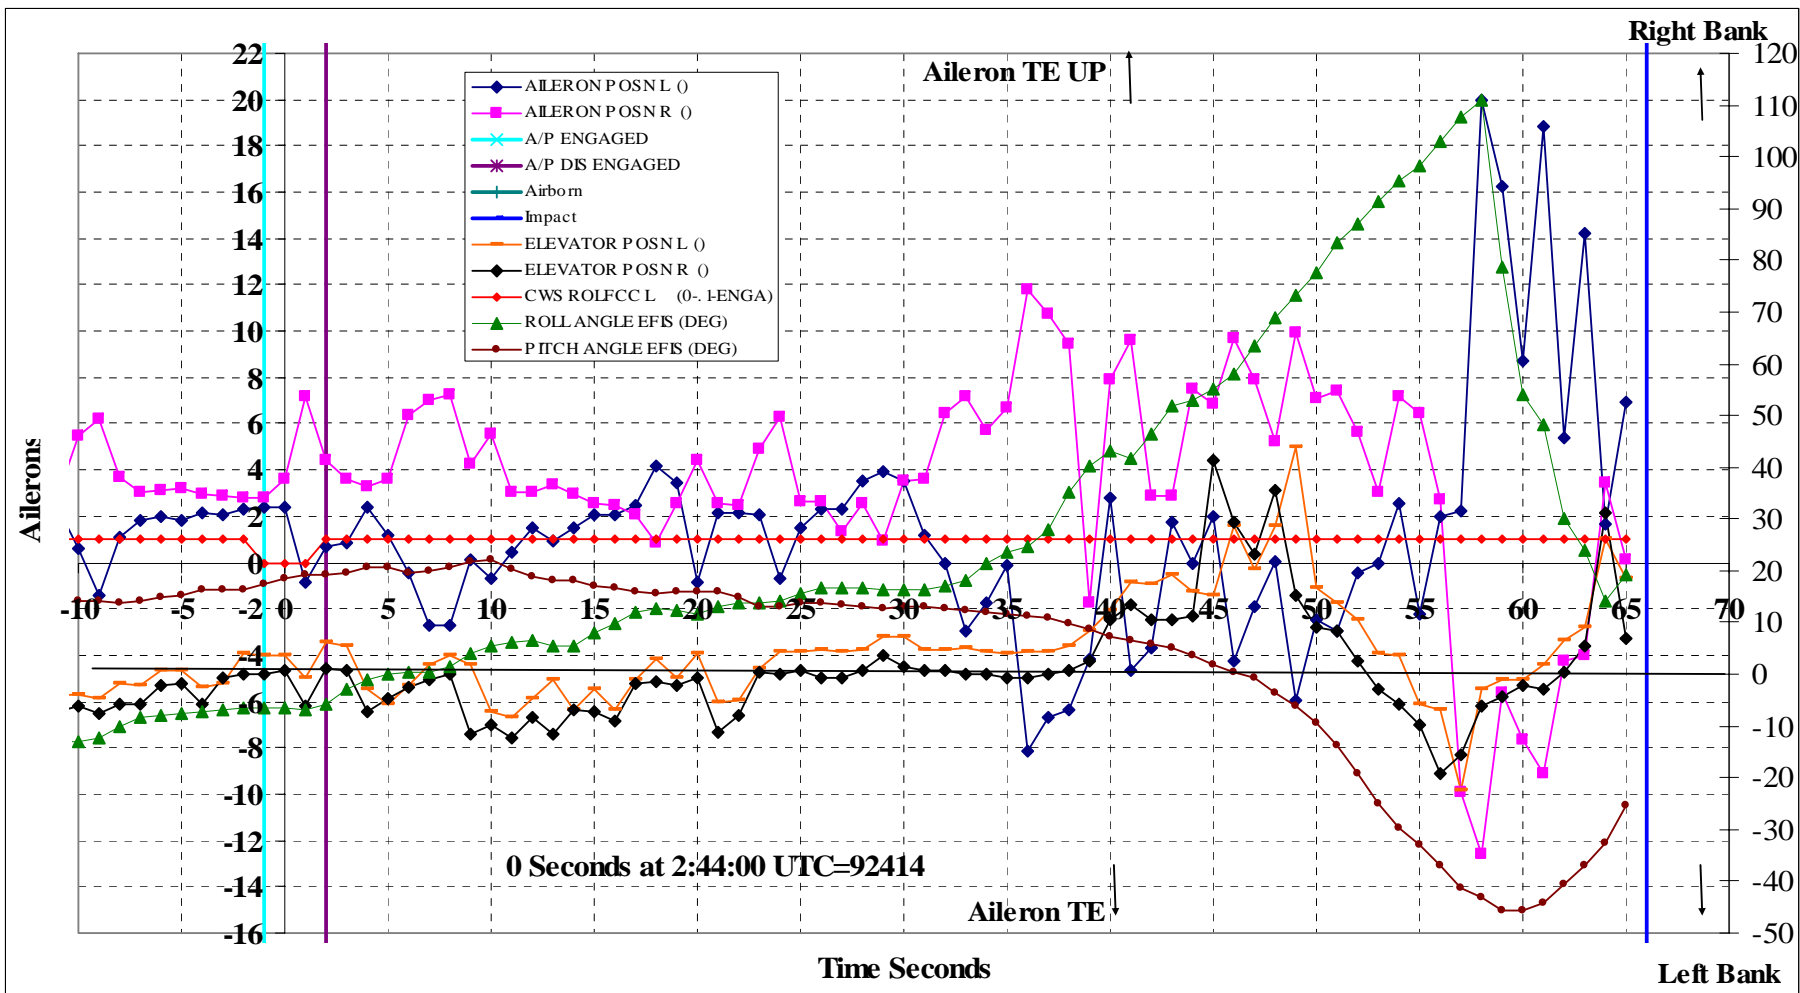
Figure 2.5.13.1a Right roll continues to overbank with ailerons activities

Based on the FDR and the CVR data, the airplane continued the right overbank until a maximum of 111 degree at about 92472.

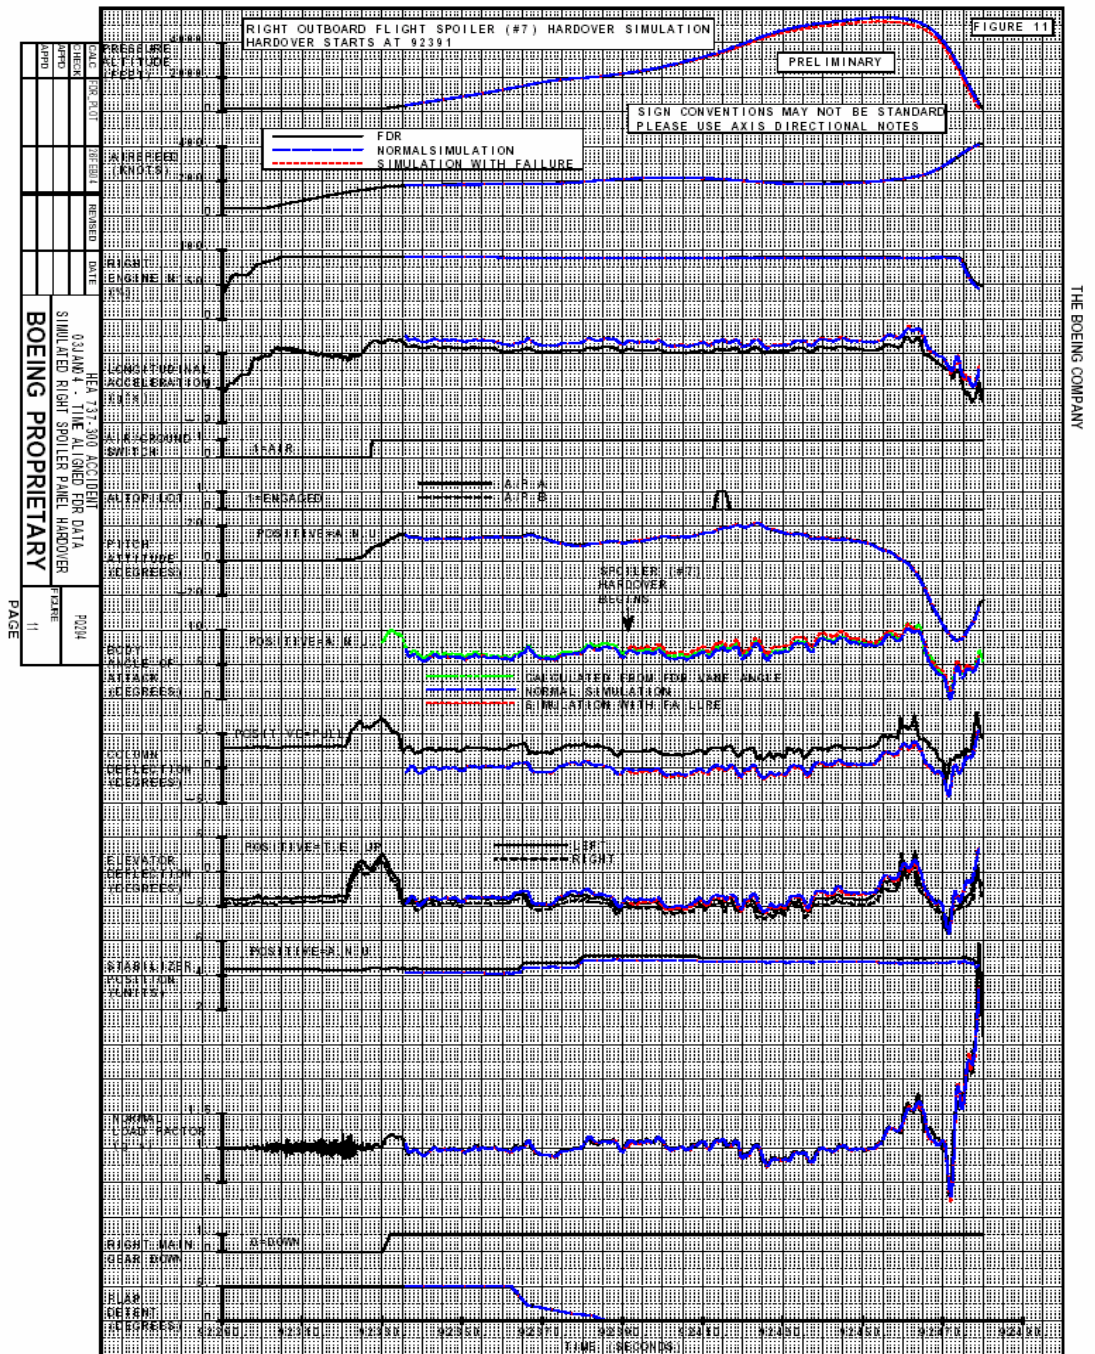
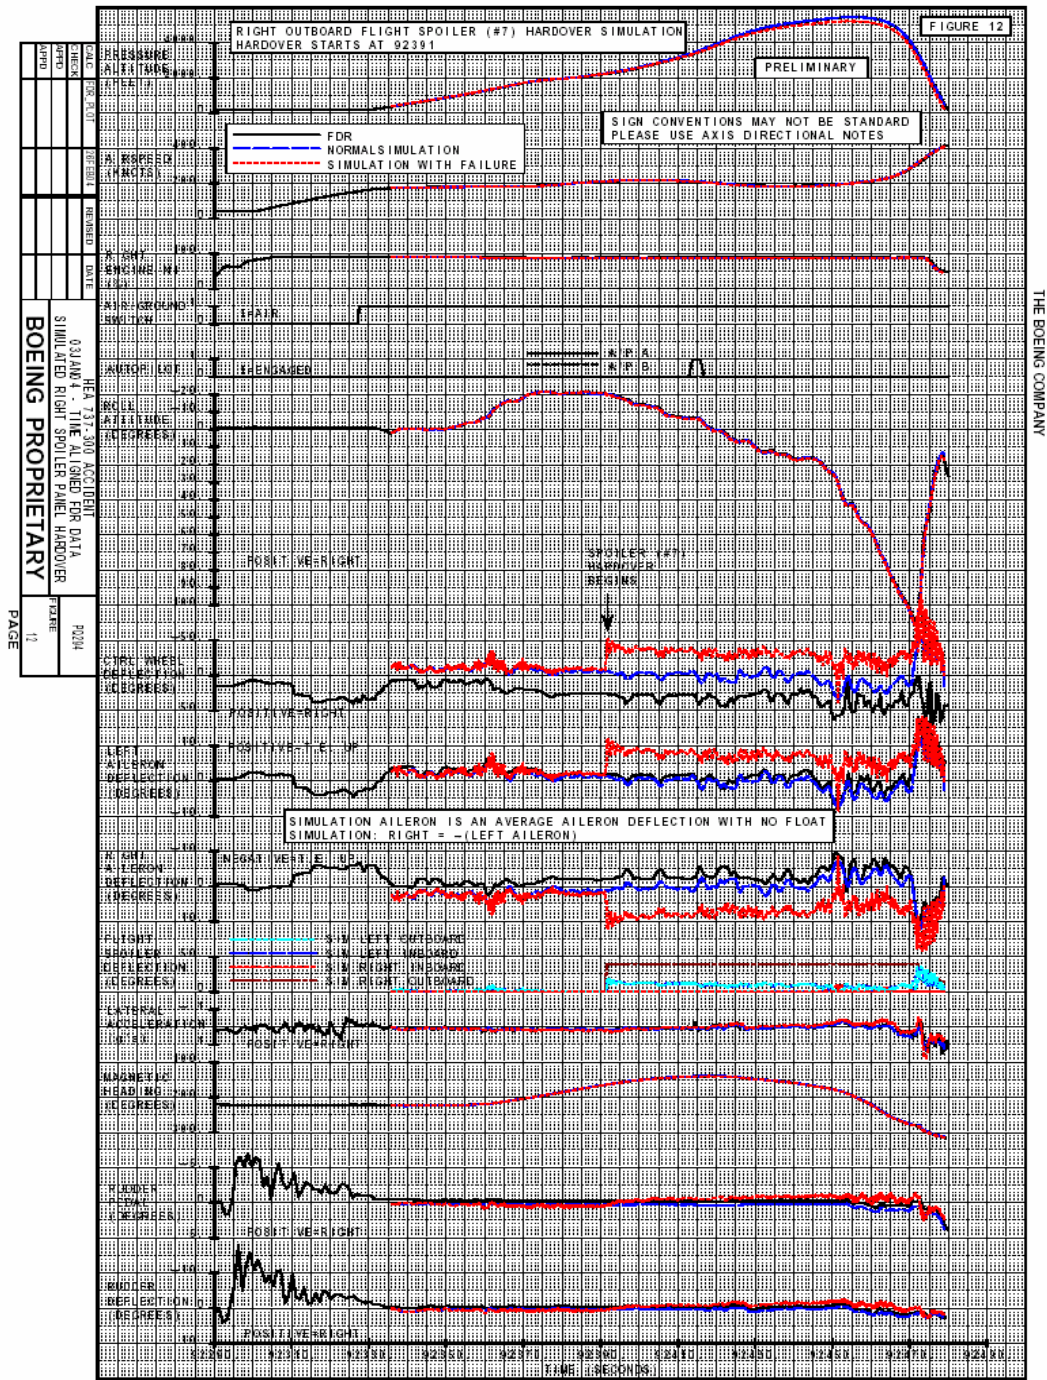
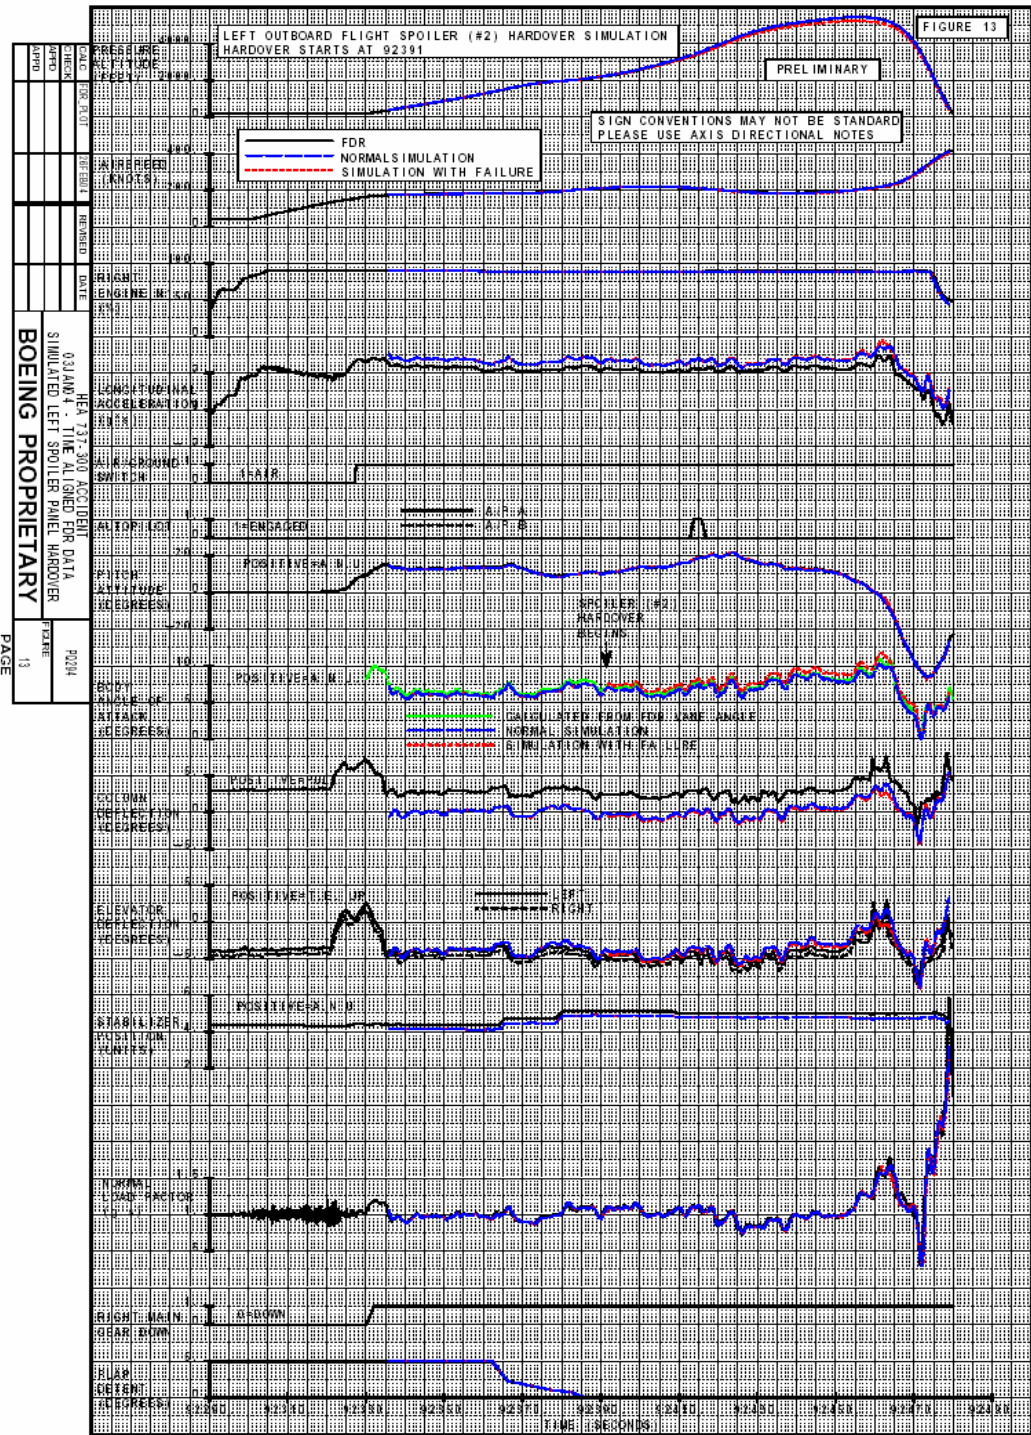
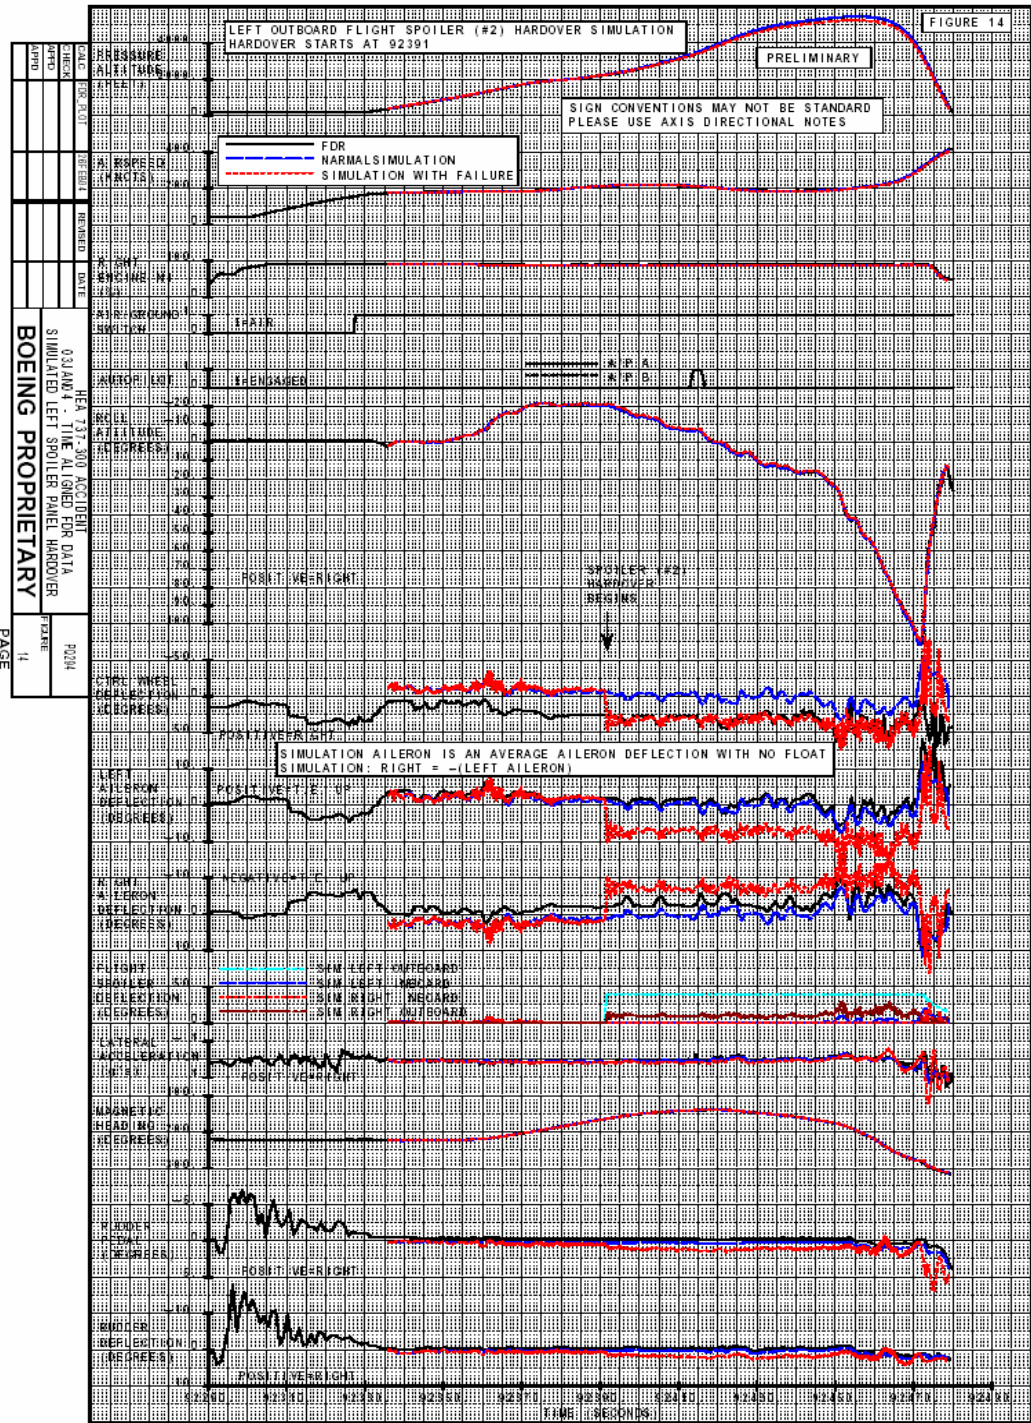
Based on the M- Cab results (Simulator match to FDR, Faults Simulations, results of spoilers' hardover conditions are shown hereafter), this condition shows inconsistency with the accident scenario. Therefore, this fault could be ruled out.
